MOUNTAIN WATER

and the TOWN

Intermountain Region

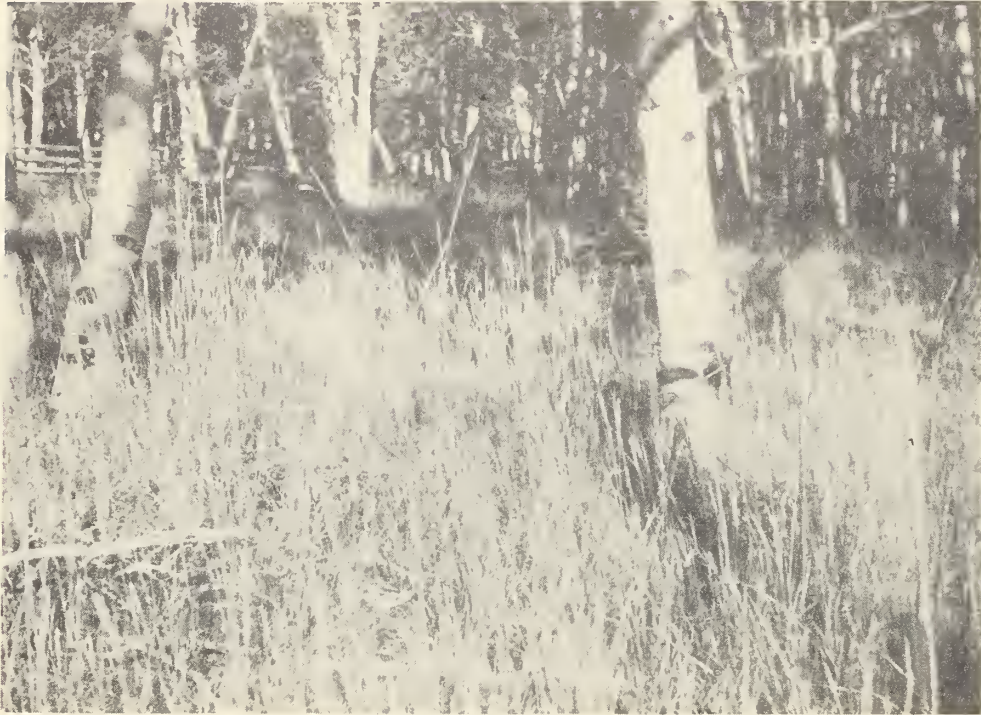
BEFORE - - -

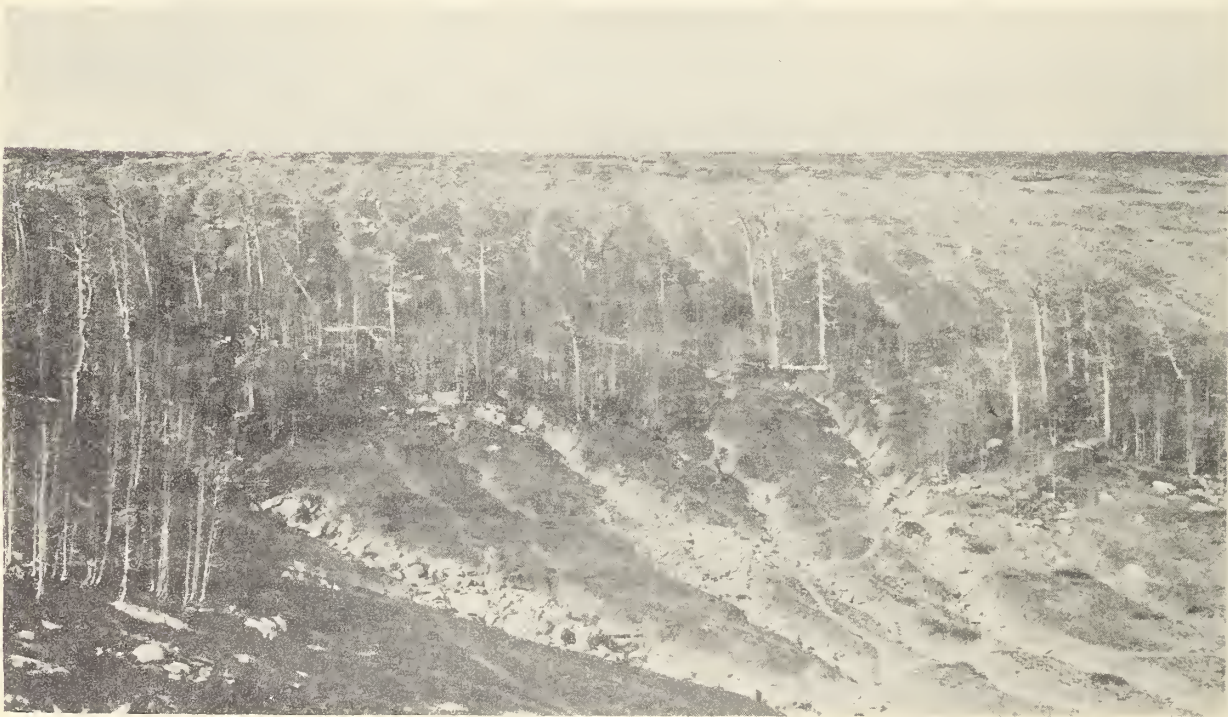
AND AFTER MAN'S ABUSE.

In 1906, the Fillmore watershed was added to what is now the Fishlake National Forest. By that time, however, so much soil had been washed off the mountain slopes, natural healing was and still is almost imperceptible. A threat still exists to 26 homes and the municipal water supply intake lying below the unhealed flood menace area. Costly contour trenching, reseeding and close protection from grazing for many years will be necessary to restore a protective plant cover on watershed slopes and ridges.

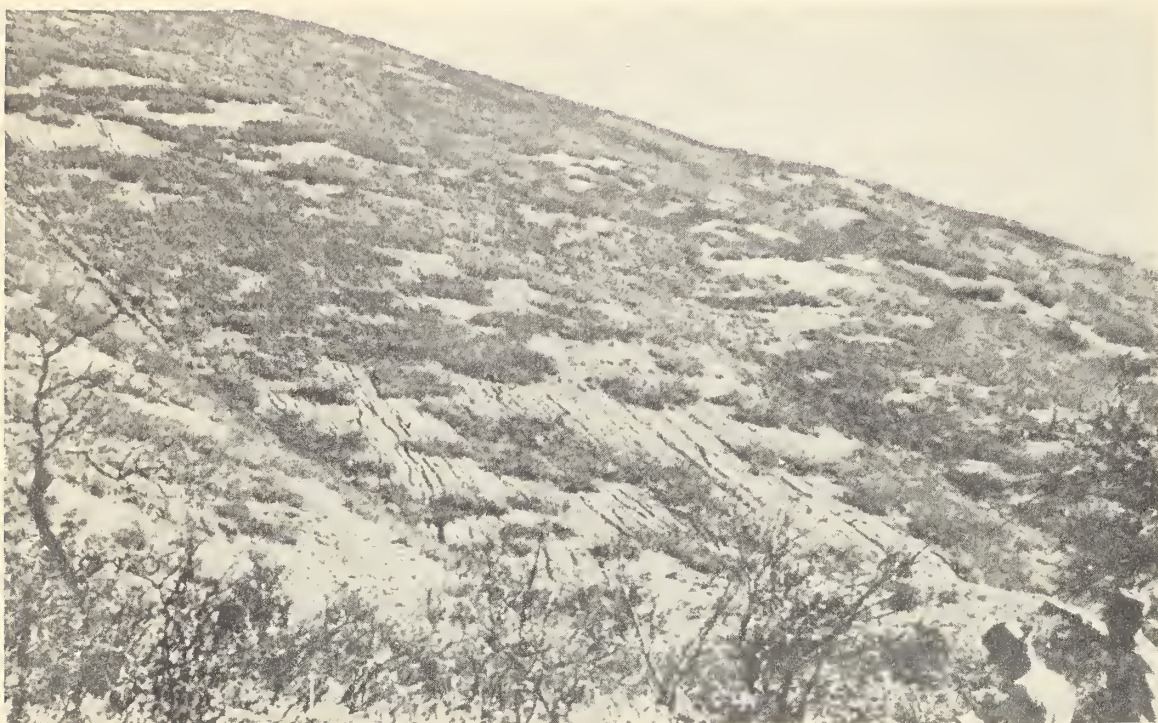
1944 - FLICK OF A MATCH.

A cigarette or match carelessly dropped one dry October day in 1944 was the indirect cause of a ruined alfalfa field. The fire started just below the old Castilla Resort in Spanish Fork Canyon and raced up the steep hillside to burn 80 acres of oak brush. It travelled fast in the cheatgrass which had replaced the native bunchgrass depleted through overgrazing.

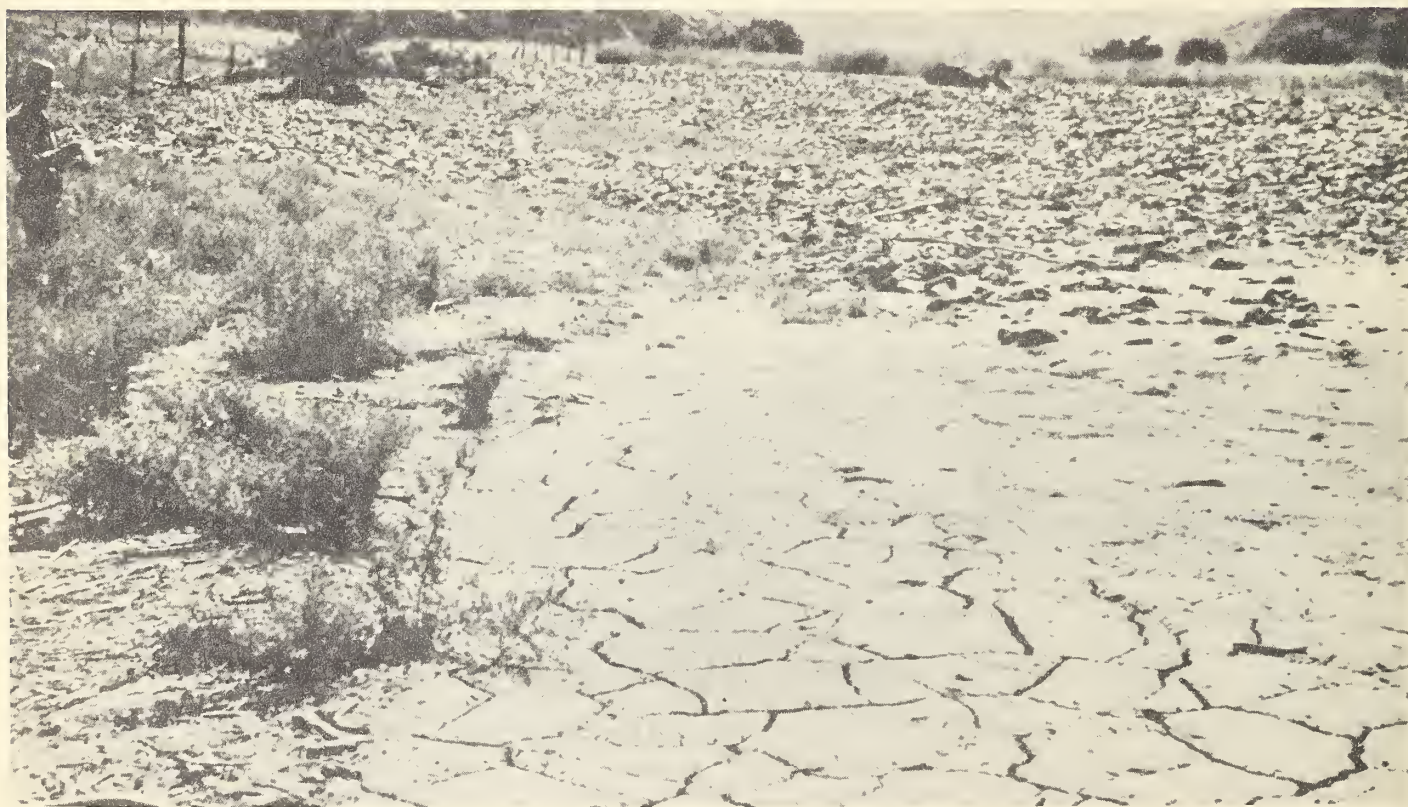
1945 - FLOOD ON THE FARM .

On August 16, 1945, before the burned area had time to become revegetated, a heavy shower, typical of our intense summer storms, hit the watershed. From this burned area, mud, rocks, and debris were swept down to the valley and came to rest on an alfalfa field adjoining the highway. No mud-rock flow came from adjoining unburned land although it received rainfall as intense as did the burned area.

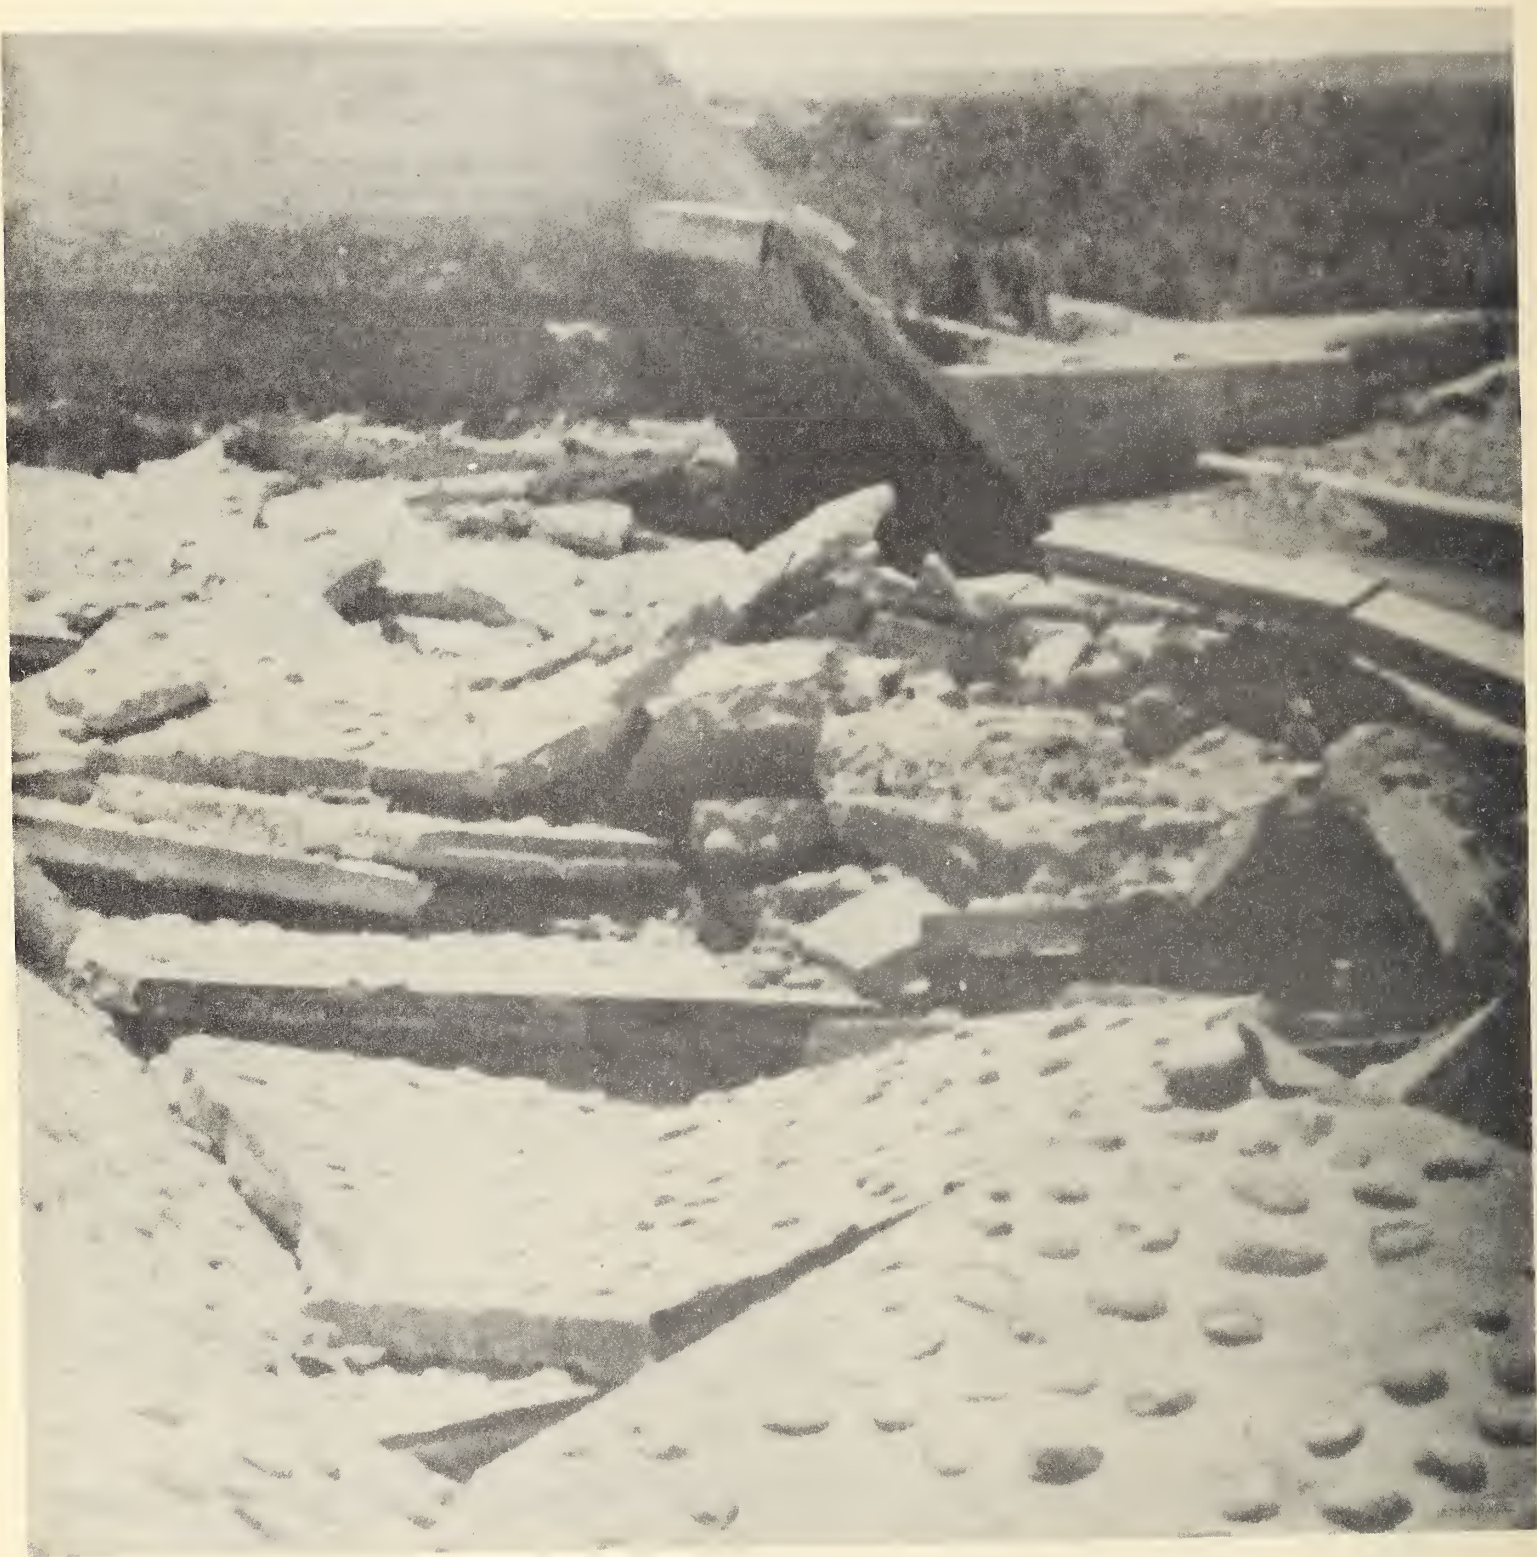
... FLOOD CONTROL STRUCTURES CRUMBLE LIKE SODA CRACKERS.

In 1938 a flood, originating on overgrazed and burned over range, caused \$167,000 damage to farm lands along Meadow Valley Wash. Damage to the railroad exceeded \$200,000.

Danger of floods originating on overgrazed or burned upstream land can be minimized only through proper land management. Plant cover must be restored so that soil can be held on the steep slopes.

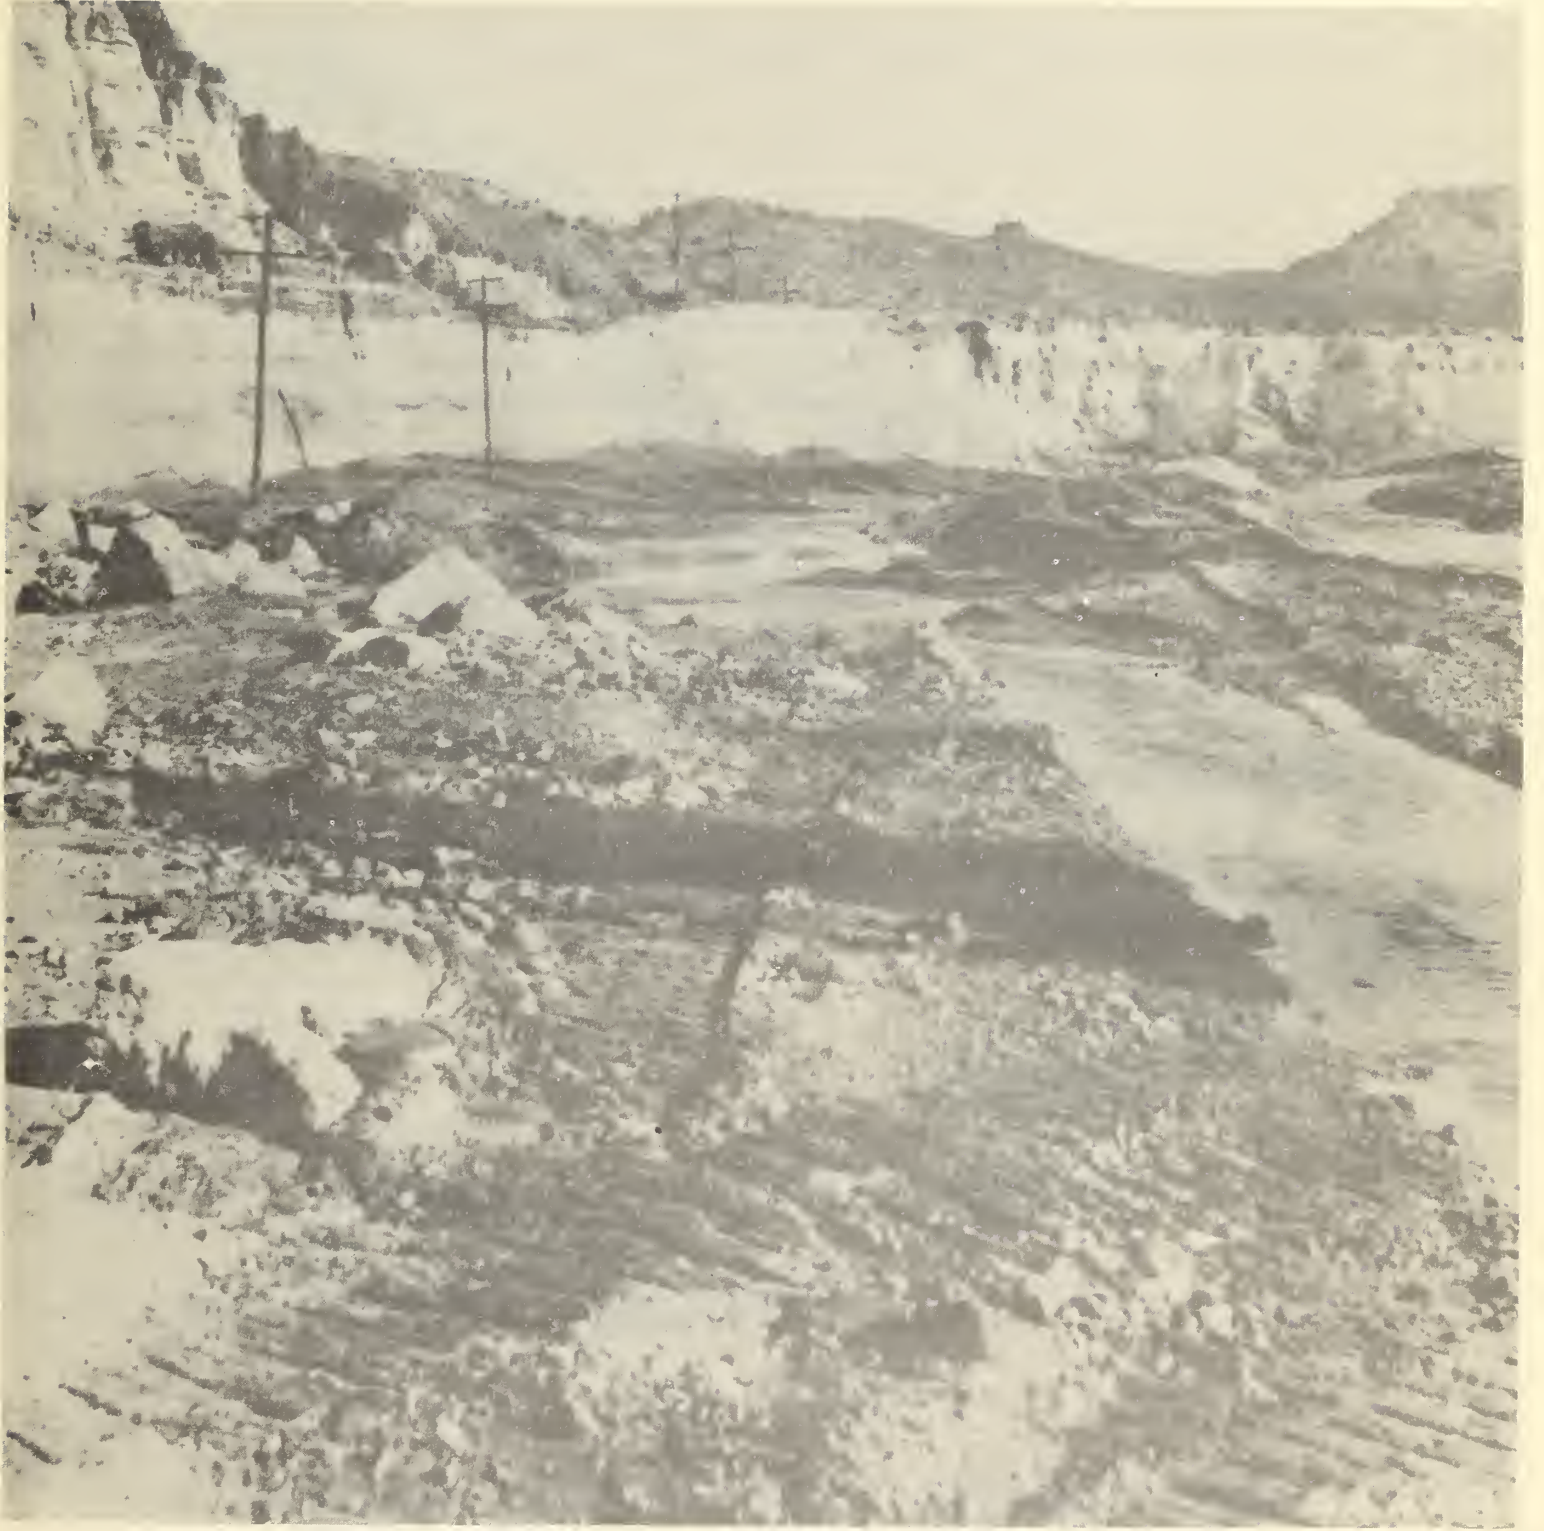
RECURRING FLOODS GOUGE DEEPER AND WIDER WASHES.

These repeated floods have reduced the area of farm lands along Meadow Valley Wash about 50 percent. Silt is carried down in large quantities and deposited on farm lands of Moapa Valley and in Lake Mead.
